Manhole Inspection Summary

Manhole # S33M__028MH

Location Address: **501 S.Sharp St.**

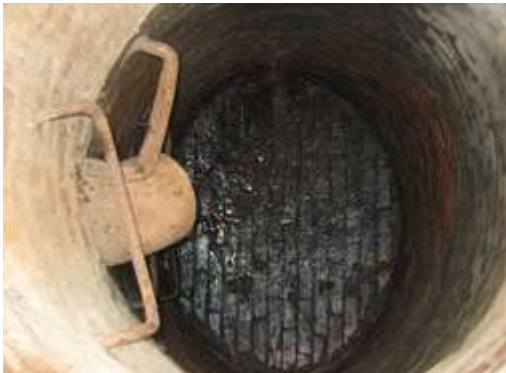
Top View

8:00 might be a drain line

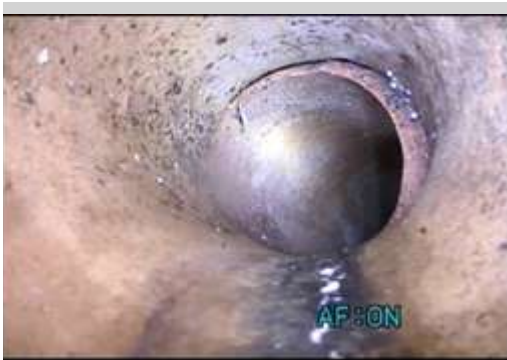
Miscellaneous

inside 8:00 pipe

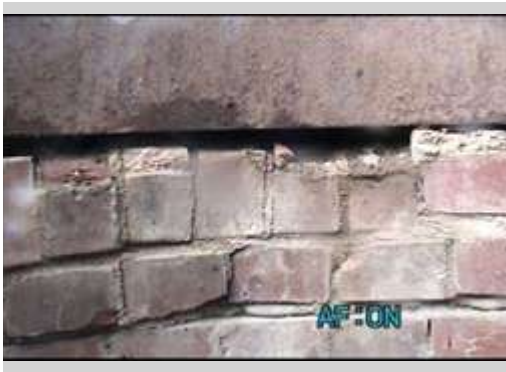
Defect 3

Condition: ☐ Sound ☐ Cracked ☐ Root Intrusion ☐ Loose Brick ☒ **Deteriorated**

deterioration at chimney and frame joint

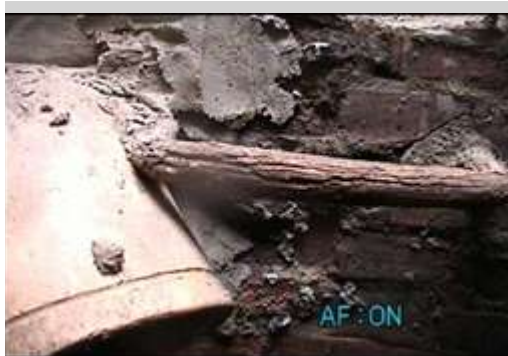
Defect 2

Count: **6** Missing: **0** ☒ **Corroded**

corroded rung

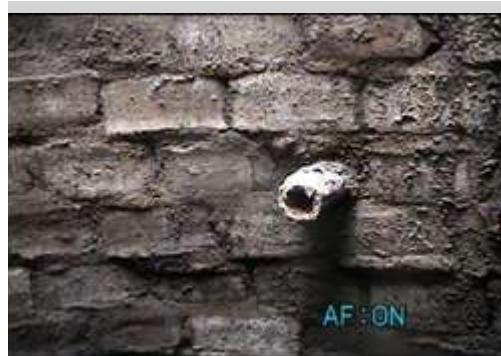
Defect 1

Infiltration: ☐ None ☐ Joint ☐ Cracks ☐ Mortar ☐ Roots ☒ **Wall**

corbel infiltration at wall around the corporation

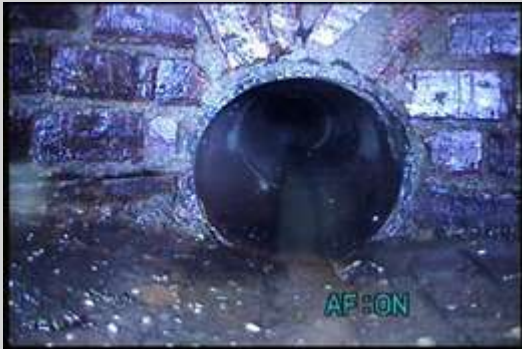
12 O'Clock Outflow

8 in. Circular Gravity Sewer
Pipe Out @ 12 O'Clock

Pipe Height: **8.4** (in.) Rod and Bar (Angled)
Pipe Material: **Clay** ☐ Pipe Lined
Invert Depth: **10.30** (ft.) Flow Characteristics: **None**
Deposits: ☒ None ☐ Mud ☐ Sludge ☐ Debris ☐ Grease
Silt Depth: **0** (in.) Deposits Extent:
Infiltration: **None** Pipe Seal Cond: **Sound**

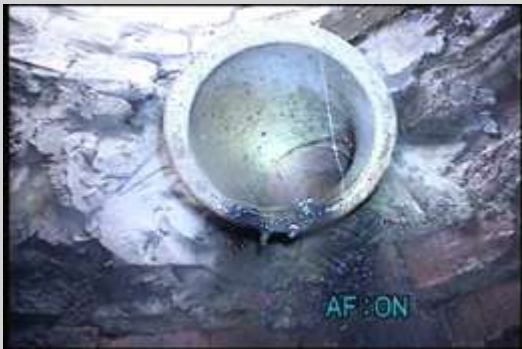
8 O'Clock Inflow

8 in. Circular Gravity Sewer
Pipe In @ 8 O'Clock

Pipe Height: **7.2** (in.) Rod and Bar (Angled)
Pipe Material: **Clay** ☐ Pipe Lined
Invert Depth: **5.30** (ft.) Flow Characteristics: **None**
Deposits: ☒ None ☐ Mud ☐ Sludge ☐ Debris ☐ Grease
Silt Depth: **0** (in.) Deposits Extent:
Infiltration: **None** Pipe Seal Cond: **Sound**
